FIRE NOTE

ISSUE 55 MARCH 2010

PROTECTING OUR WATER RESERVOIRS WITH SEDIMENT TRAPS

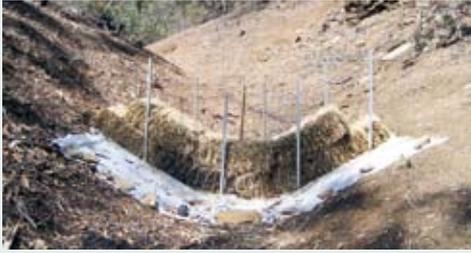
ADVANTAGES	DISADVANTAGES
Hay Bales

<ul style="list-style-type: none"> • Simple to install • Inexpensive – cheapest of the three options • Fast to construct • Easily transported • Easily obtained • Material decomposes • Simple removal 	<ul style="list-style-type: none"> • Not suitable for high velocity water • Can introduce weeds* • Eaten by fauna* • Last for a short time frame (6 months)* • Needs monitoring and maintenance
Coir Bales

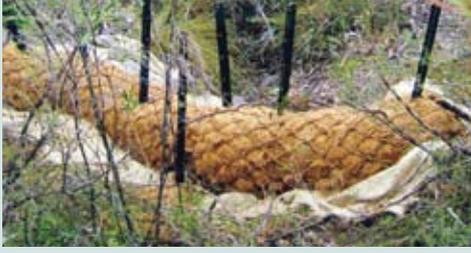
<ul style="list-style-type: none"> • Very simple to install • Very fast to construct • Does not introduce weeds • Easily transported • Lasts for a reasonable time-frame (1.5 to 3 years) • Material decomposes • Simple removal 	<ul style="list-style-type: none"> • Not suitable for high velocity water • Not always quickly available • Needs monitoring and maintenance
Silt Fencing

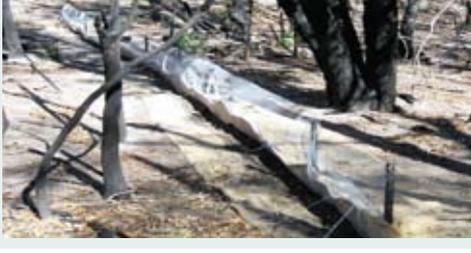
<ul style="list-style-type: none"> • Can deal with high velocity water • Does not introduce weeds • Can trap large amounts of sediment depending on trap size • Material can be stockpiled ready for an emergency response 	<ul style="list-style-type: none"> • Slow construction • Trap construction is not simple • Requires trenching to install which disturbs the site • Material does not decompose • Complex removal • Needs monitoring and maintenance

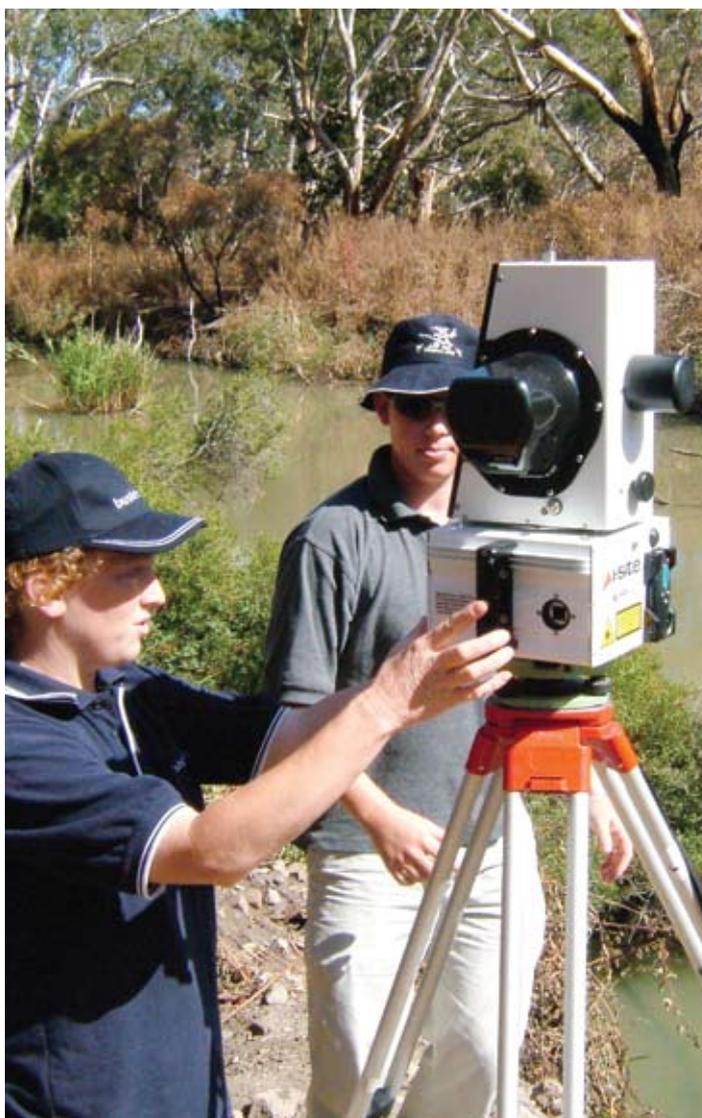
◀ Researcher Rowena Morris and James Moncrief, from Mapttek, operating the terrestrial laser scanner.

Terrestrial laser scanning (TLS): land based surveying using laser technology that creates highly accurate 3D data (See photo page 3).

Part of this research trialled terrestrial laser scanning (TLS: see 'Definitions' box). TLS enables researchers to capture high-resolution temporal and spatial data sets to assess post-fire erosion. The novel approach of this method at Mount Bold provided entire hillslope data in previously inaccessible terrain. The data assists in interpreting where and how the sediment moves following fire. This project is still analysing the TLS data in relation to the sediment traps.

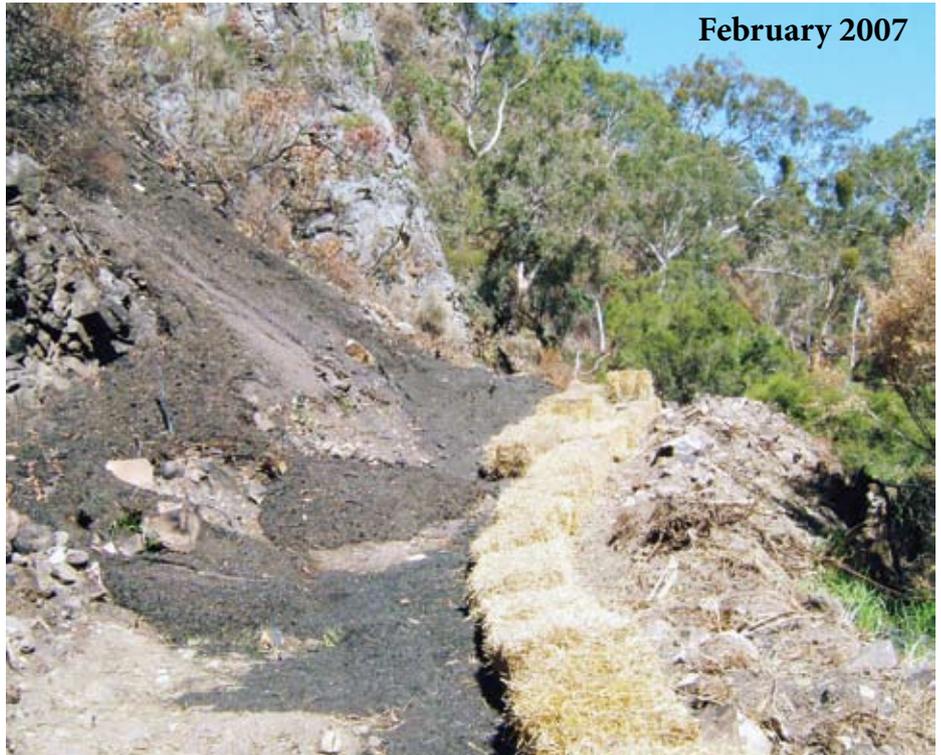
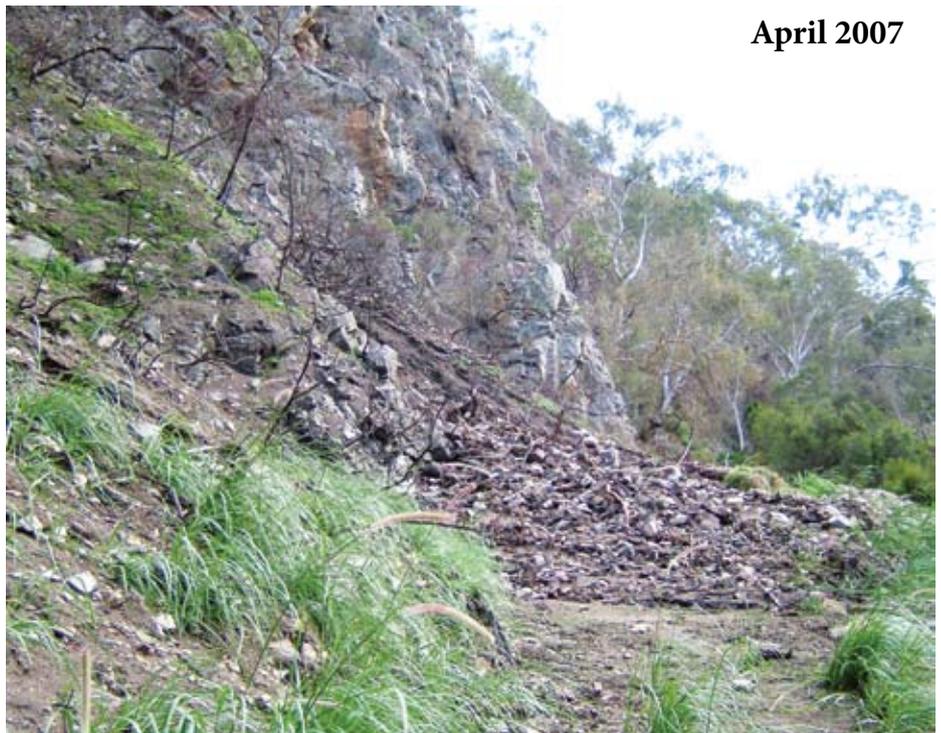
February 2007

April 2007

▲ Before and after the April 2007 rainfall event. Pyrocolluviation overtopped the hay bales.

Pyrocolluviation: fire induced valley-fill aggradation. This means the build-up of charcoal-rich sediment at the bottom of a valley due to hillslope erosion following fires (see photos page 4).

one in five-year rainfall event. Both paleofires and current fires result in rapid build-up of charcoal-rich sediment at the bottom of a valley due to hillslope erosion, referred to as pyrocolluviation (see ‘Definitions’ box). In places with steep slopes greater than 35 degrees, gravity alone is enough to move rocks and sediment. Erosion is a problem immediately after the fire and before the vegetation has had a chance to regrow and stabilise the soil surface. This means that any emergency sediment trapping program needs to be implemented immediately after the fire and before the first substantial rainfall event.
